# HOME INSPECTION REPORT

11 Delaware Ave  
Toronto

Inspection Date: [April 8 2026](#)

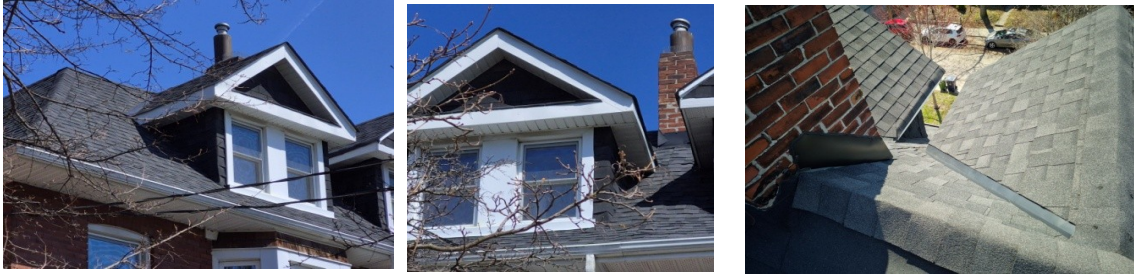
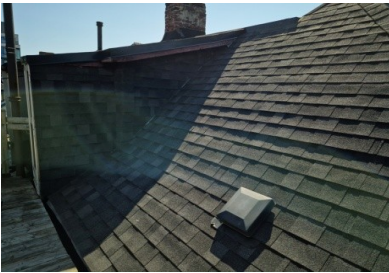
Sloped Surface: overall surface in good repair

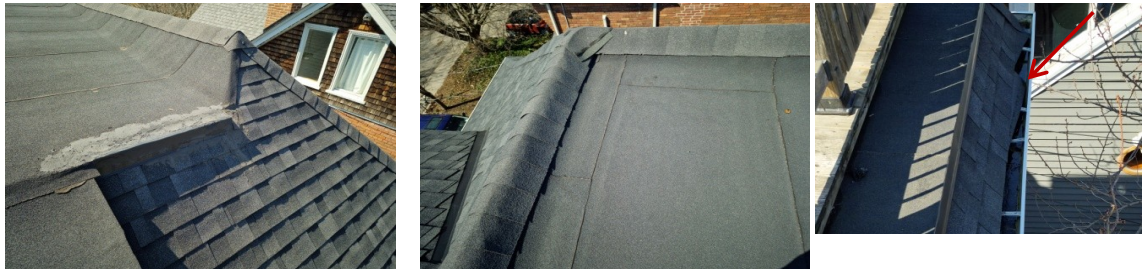
Flat Surface: overall surface in good repair, repaired along northeast - monitor/repair

2nd Flat: deck: northeast edge - loose shingles - repair

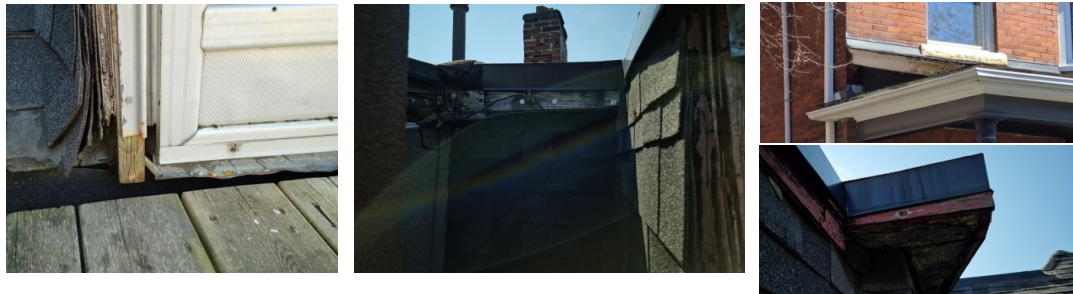
Doors: deck door: threshold - monitor/repair as required

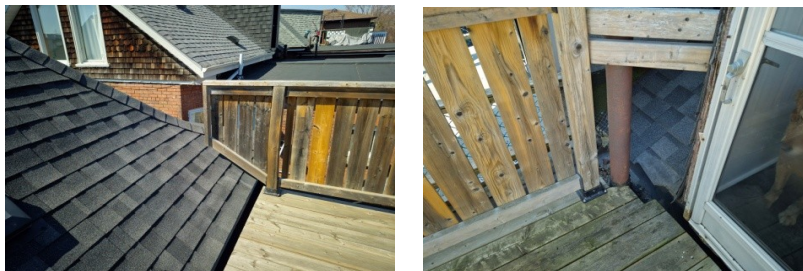
**DECK** openings at corners- safety concern - repair

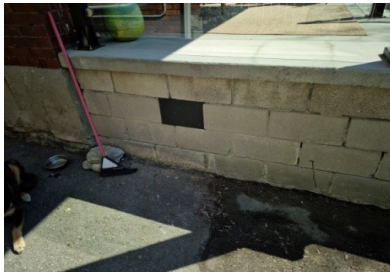
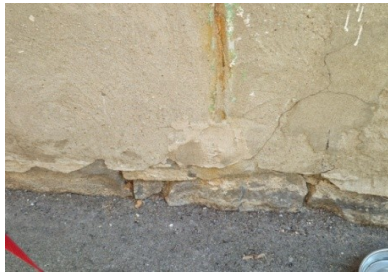
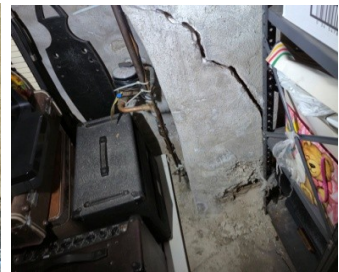
FOUNDATIONS: exterior/basement: will require general mortar repairs, typical for older house

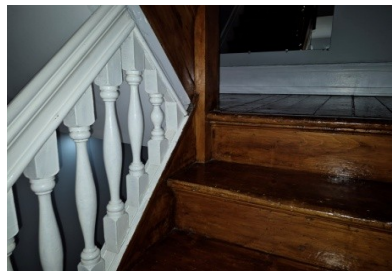
FLOORS: minor sagging around stair areas though typical for older house

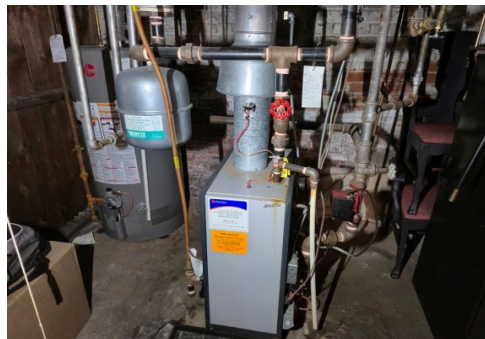
HOT WATER BOILER: service annually  
 annual CO test mandatory for this type of unit  
 recommend obtaining replacement parts/servicing contract

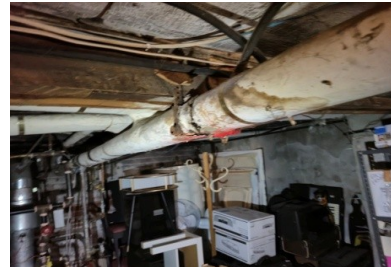
Radiator(s): monitor/repair valves as required  
 Piping: insulation on heating pipes may contain asbestos  
 encapsulating the insulation is often the best approach  
 Environmental Consultants can assist if this is a concern

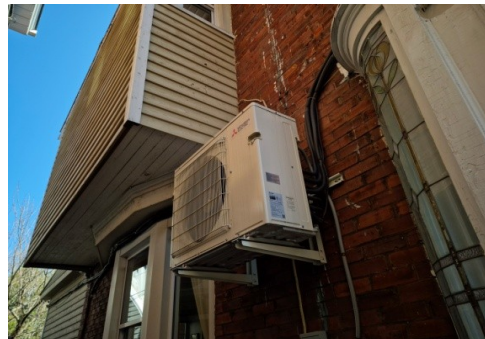
DUCTLESS HEAT PUMP: 4 zone wall mount units  
unit provides cooling and supplemental heating  
not tested in cooling mode
