HOME INSPECTION REPORT

265 Ontario St
Toronto

Prepared by: Bob Papadopoulos P.Eng., RHI *

Inspection Date: March 18 2020

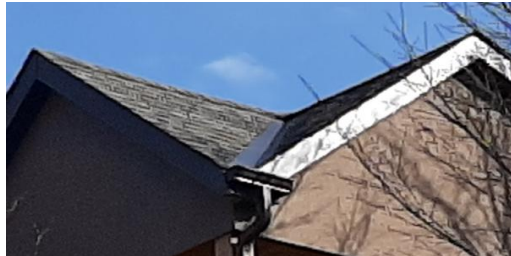
Sloped Surface: [overall surface in good repair](#)

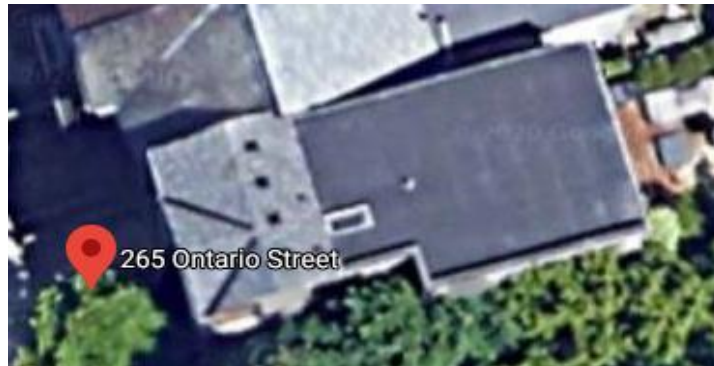
Flat Surface: [not visible due to height](#)
[Google Map appears roof is in good repair](#)

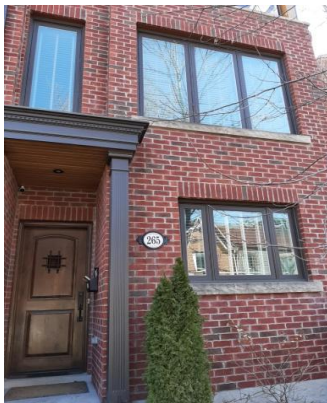
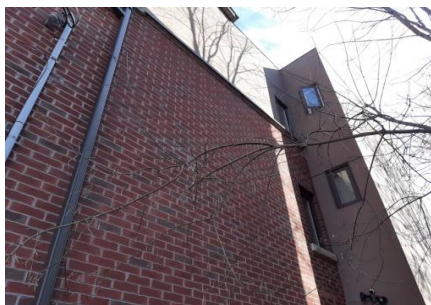
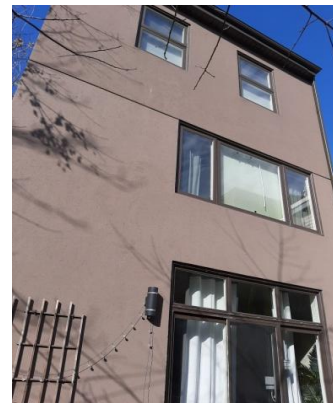
WALL SURFACES: overall in good repair
DOORS/WINDOWS: overall in good repair, repair caulking along bottom of rear door

PORCH overall in good repair, minor column repairs at base

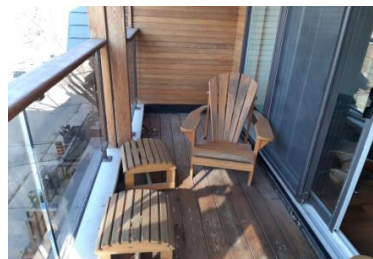
DECK overall in good repair
BALCONY: overall in good repair
scupper drain requires cleaning

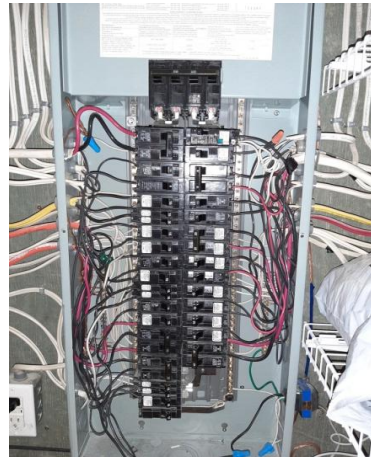
SERVICE PANEL: **overall in good repair**

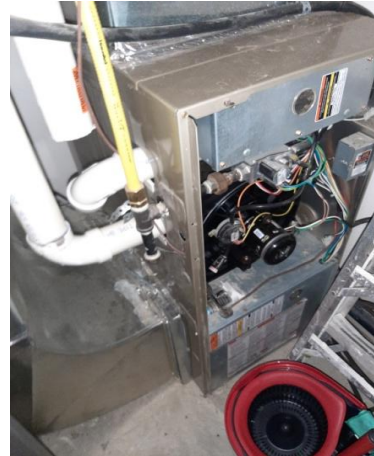
FORCED AIR FURNACE: [service annually](#)
Filter: [replace 1-per-3 months](#)

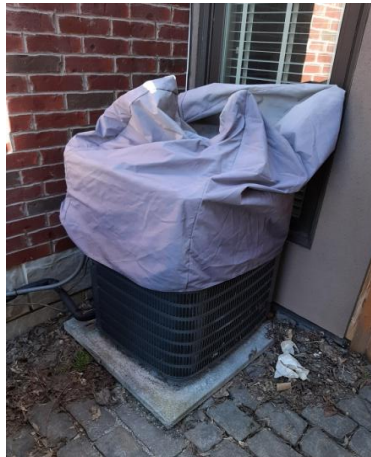
AIR CONDITIONER: not tested: should be serviced before using

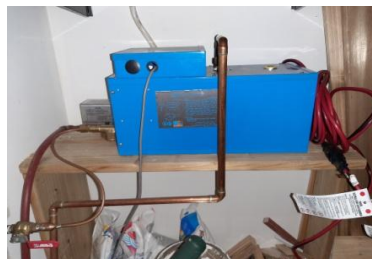
Comments: basement steamer was functional should install drip pan and drip tube to safety valve - minor

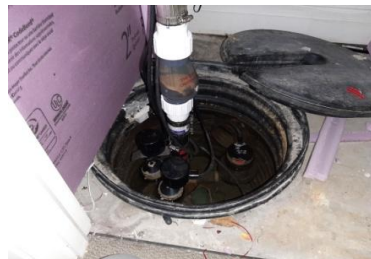
sump pump: service annually, recommend lower float to minimize
 standing water in sump pit, sump pump includes a back up battery
