HOME INSPECTION REPORT

3420 Grand Forks Rd

Inspection Date: June 14 2016

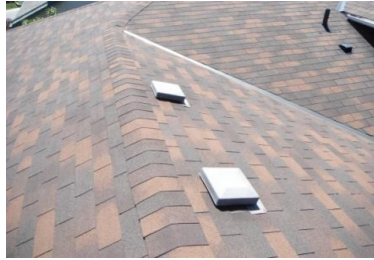
Roofing: overall surface in good repair

Note: Recommend Annual Maintenance Contract for Roof Surface, Flashing Details and Chimney(s)

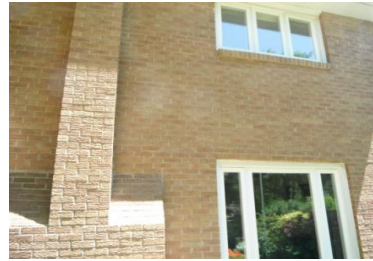
WALL SURFACES: overall in good repair
DOORS/WINDOWS: overall in good repair

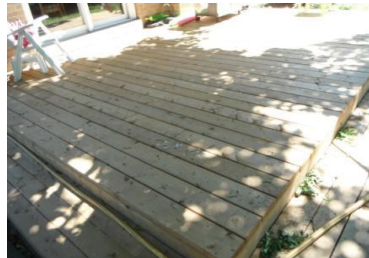
DECK new deck

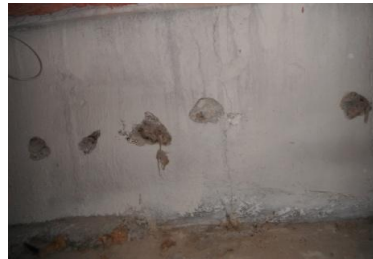
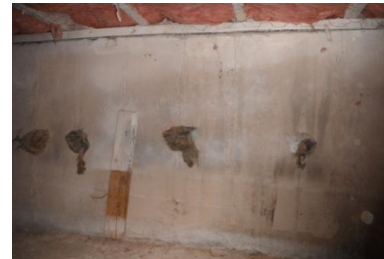
FOUNDATIONS: typical settlement cracks

1. gutters, downspouts, grading, driveways: ongoing maintenance and repair/see Exterior
2. cracks/form ties on foundation: monitor/repair as required
3. excavation/damp-proofing: monitor basement, consider step 3 as a last resort should leaking persist

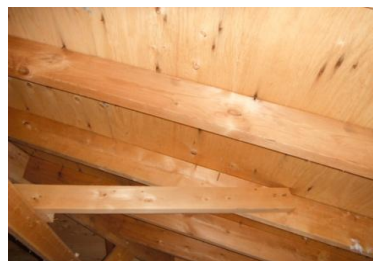
FLOORS: basement area- newer joists/beams

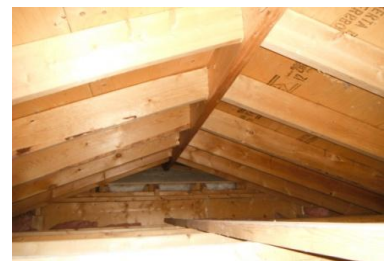
ROOF: newer structure approx. 2005

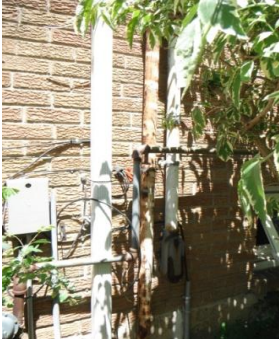
SERVICE ENTRANCE:
Mast: **rusting, replace if required**

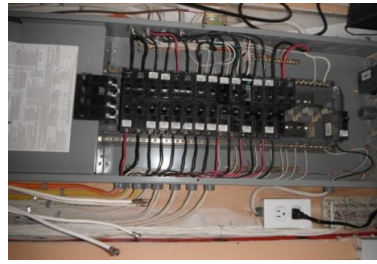
SERVICE PANEL: **overall in good repair**

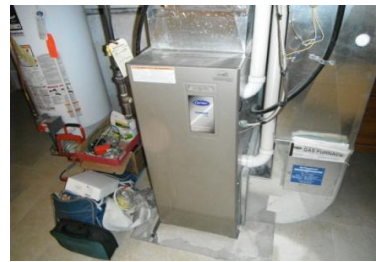
FORCED AIR FURNACE: [service annually](#)
[rusting noted inside of cabinet](#)

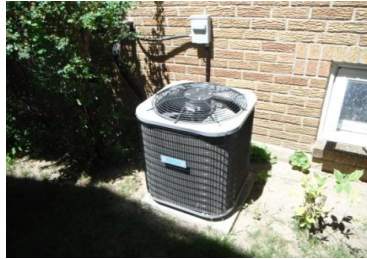
AIR CONDITIONER: [service annually](#)

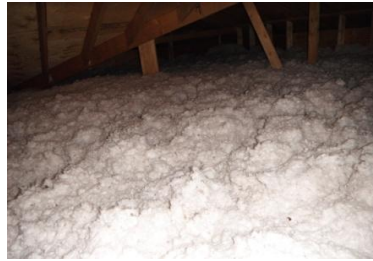
ROOF SPACE: insulation and ventilation is adequate

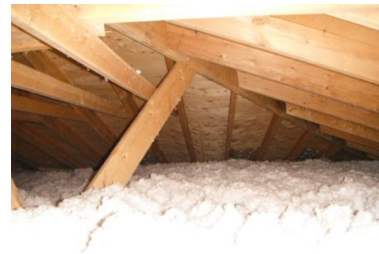
Roof Access Hatch: insulate and weather-strip access hatch to roof space
