HOME INSPECTION REPORT

4342 Violet Rd
Mississauga

Prepared by: Bob Papadopoulos P.Eng., RHI *

Inspection Date: [Sept 25 2025](#)

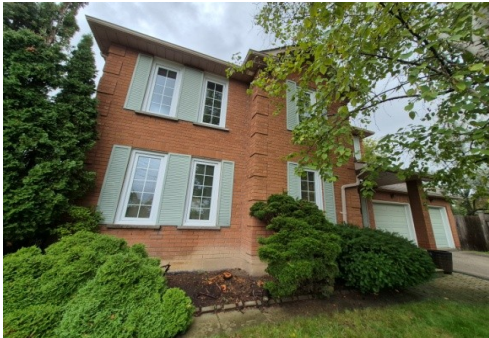
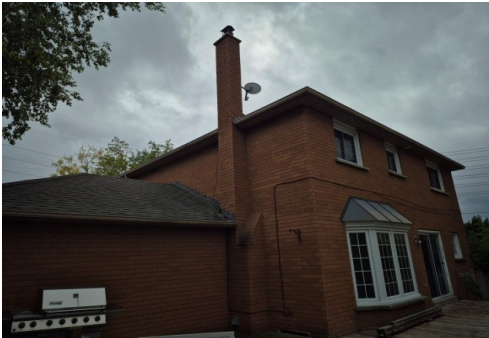
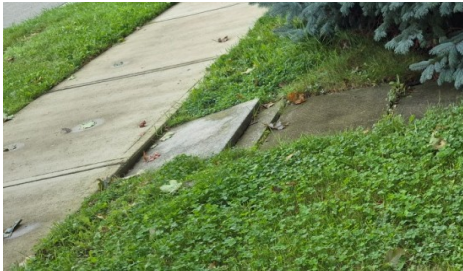
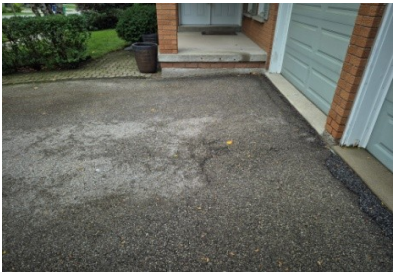
| <p>**Gutters/Downspouts: requires general repairs and maintenance</p> <p>WALL SURFACES: overall in good repair</p> <p>DOORS/WINDOWS: overall in good repair</p> <div> </div> <p>**Driveway(s): older cracking surface, maintenance as required, budget to re-surface</p> <p>DECK(s): older, ongoing maintenance</p> <p>Doors: side door not in use</p> <p>**Walk(s): side walkway not in use, settlement near edge - trip hazard</p> <div> </div> | | | |

| <p>Note: Maintain Gutters & Downspouts annually. Extend Downspouts at least 6-feet away from the house</p> <p>** Any or all these items may contribute to Basement Leakage. Please see Interior Page</p> | | | |

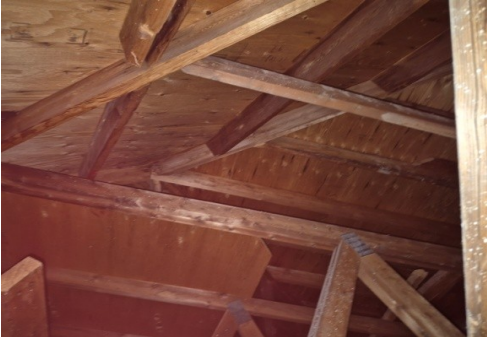
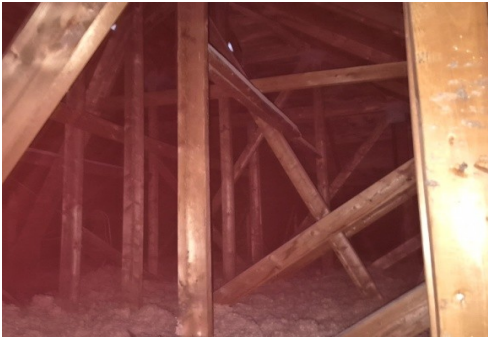
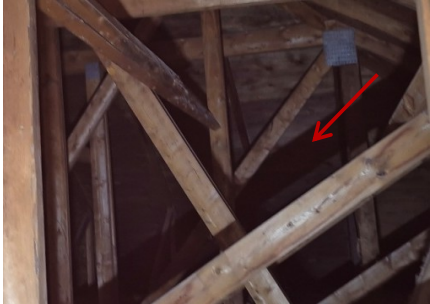
| <p>overall well built house</p> <p>ROOF: overall in good repair</p> <div style="display: flex; justify-content: space-around;"> </div> <p>Comments: some minor staining on north underside of sheathing though does not appear to be mould Environmental Consultants can assist if this is a concern if remediation require typical \$2000 to \$4000</p> <div style="text-align: center;"> </div> | | | | |

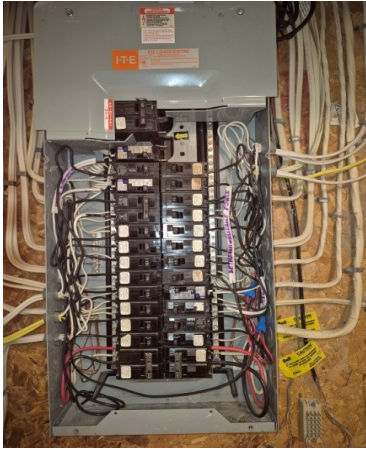
| <div>SERVICE ENTRANCE: overall in good repair</div> <div>SERVICE PANEL: overall in good repair</div> <div></div> | | | |

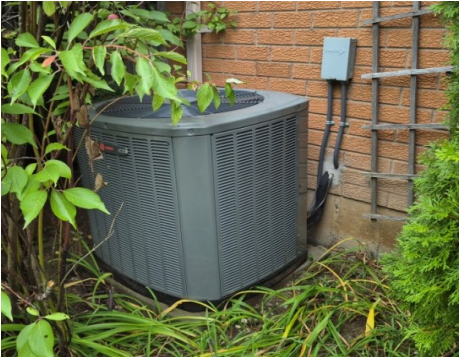
| <p>AIR CONDITIONER: service annually</p> <div></div> | | | |

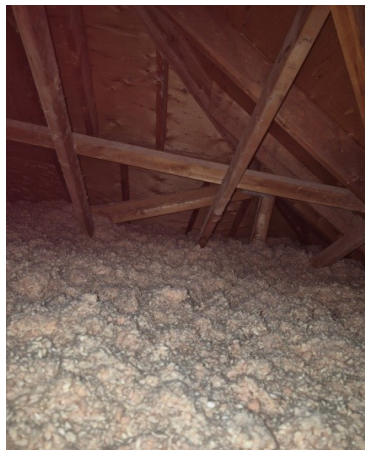
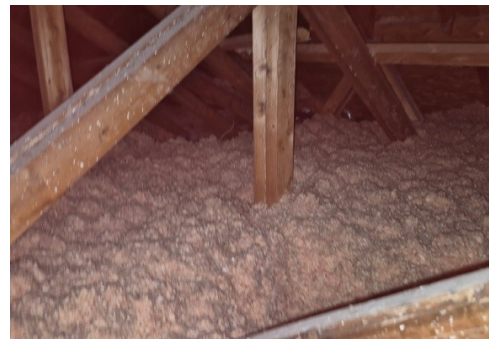
ROOF SPACE: insulation and ventilation is adequate
