HOME INSPECTION REPORT

5786 Mersey St
Toronto

Inspection Date: [June 26 2024](#)

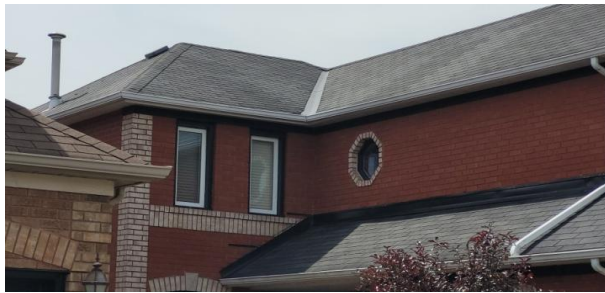
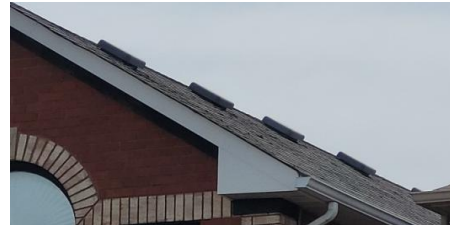
ROOFING The main shingles are aging on the south and west sides. The lower roof surfaces are newer.

Flat Surface: [west/south aging surface, repair/replace shingles as required, budget to replace within 5 years, likely more cost effective to replace throughout](#)

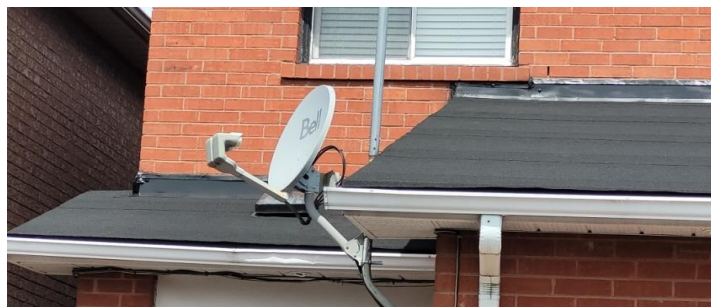
South Slope: [new surface in good repair](#)

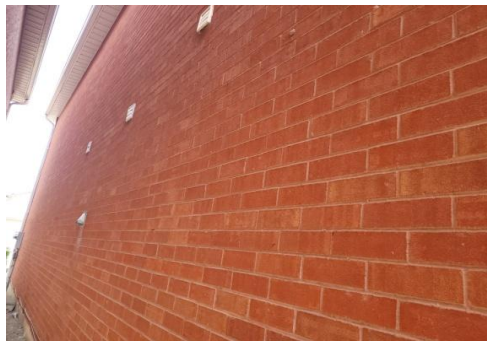
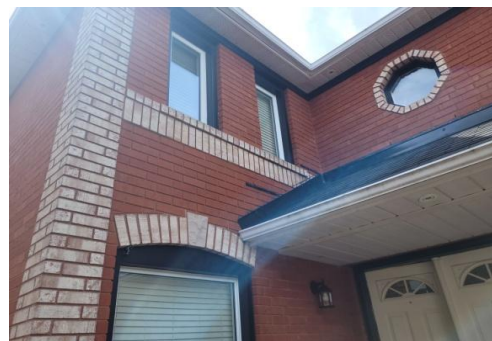
WALL SURFACES: overall in good repair
 DOORS/WINDOWS: overall in good repair
 paint to some wood components

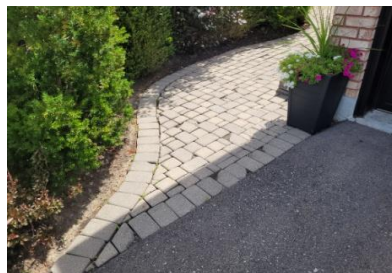
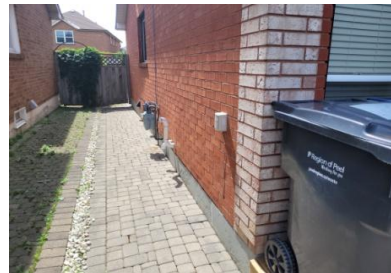
**Walk(s): some damaged/settlement pavers- repair as required

** Any or all these items may contribute to **Basement Leakage**. Please see Interior Form

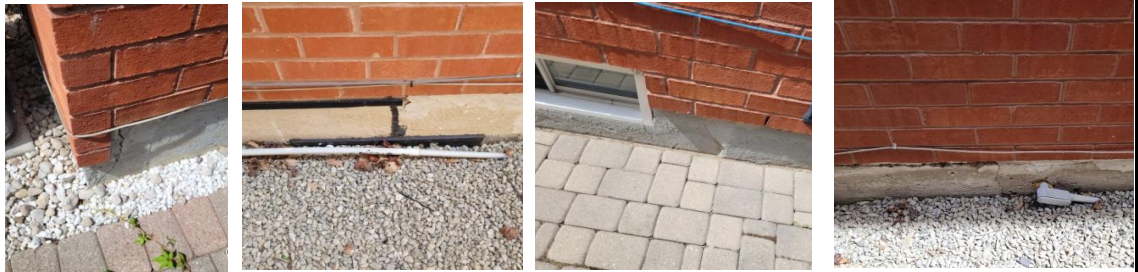
FOUNDATIONS: typical settlement/shrinkage cracks
prior repairs on west side- see Interior Basement

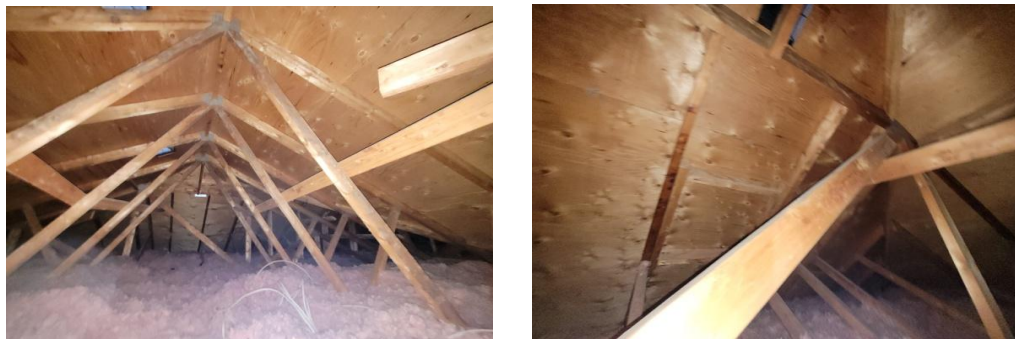
ROOF: overall in good repair

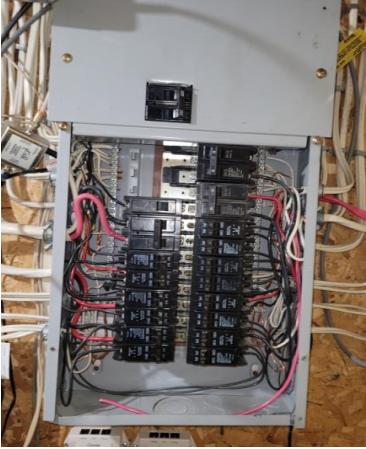
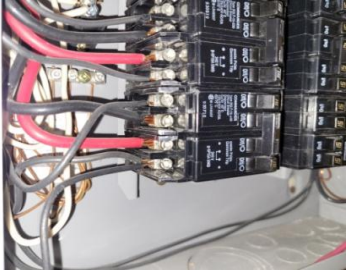
| Ref#* | <p>SERVICE ENTRANCE: overall in good repair</p> <p>SERVICE PANEL: overall in good repair</p> <p>one double tap unit (two wires in one breaker) not critical</p> <div style="display: flex; justify-content: space-around; align-items: center;"> </div> <p>Note 1: All recommendations are safety issues - Treat them as high priority.</p> <p>Note 2: Please ensure accurate labeling on panels.</p> |

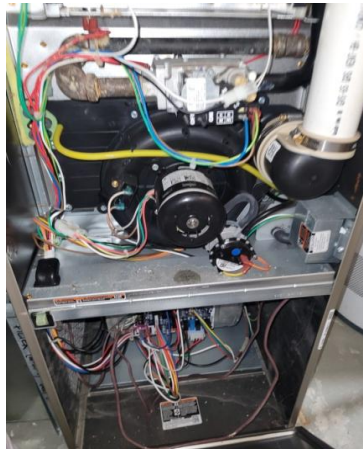
FORCED AIR FURNACE: [service annually](#)
Filter: [replace 1-per-3 months](#)

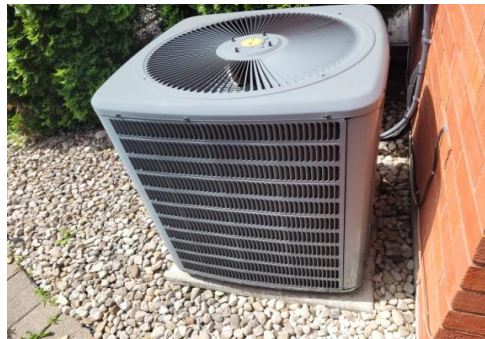
AIR CONDITIONER: [service annually](#)

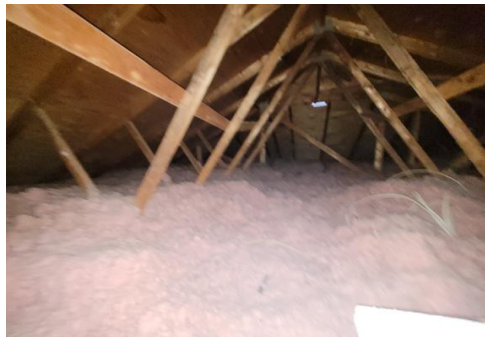
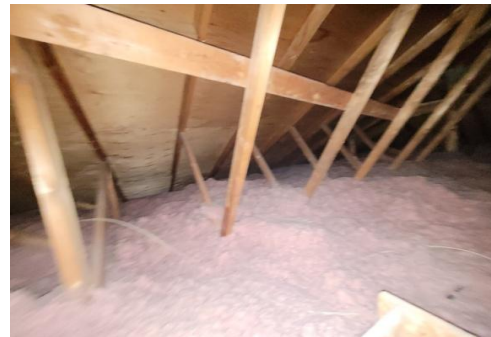
ROOF SPACE: insulation and ventilation is adequate
 various uneven/amount of insulation should be improved

Note: adding insulation is considered an improvement rather than a repair

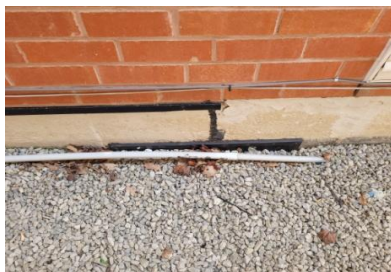
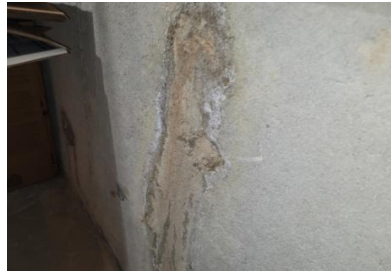
**Basement Leakage: [presently no leaking detected with moisture meter random sampling exterior west: prior crack repair/damp-proofing on foundation east side furnace room: stains at form holes - monitor, repair/seal by professional crack sealing if required - overall minor cost see steps below](#)

- gutters, downspouts, grading, driveways: [ongoing maintenance and repair/see Exterior](#)
- cracks/form ties on foundation: [monitor/repair as required](#)
- excavation/damp-proofing: [monitor basement, consider step 3 as a last resort](#)
