HOME INSPECTION REPORT

618 Ossington Ave

Toronto

Inspection Date: May 2 2017

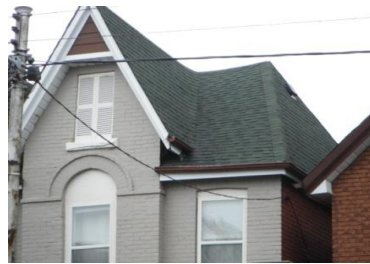
Sloped Surface: newer surface in good repair

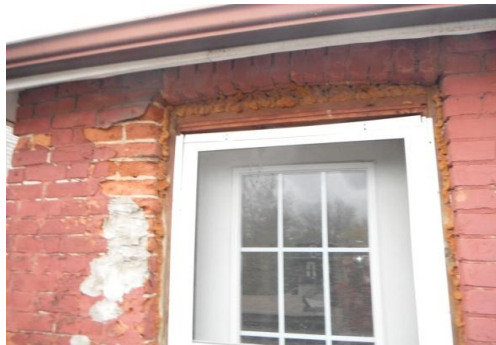
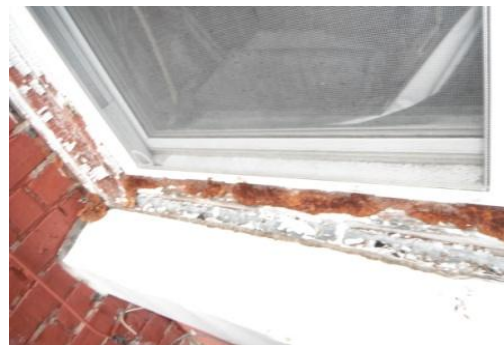
DOORS/WINDOWS: rear main level window sill requires repairs, general flashing repairs.
exposed spray foam should be trimmed and flashing installed

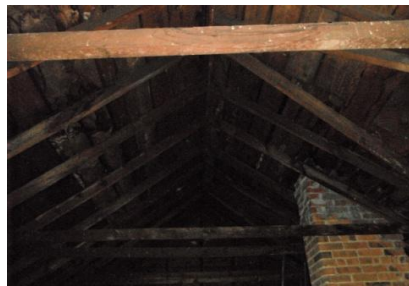
ROOF: roof was viewed from south neighbors access hatch, overall in good repair, appears that portion on east side has been shored up with metal rods, staining at underside is older since roof shingles are newer

Party Walls: recommended installing in roof space between neighbors

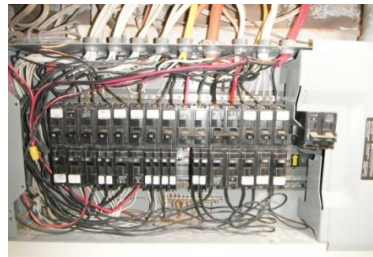
SERVICE PANEL: overall in good repair, provide cap to opening on panel cover

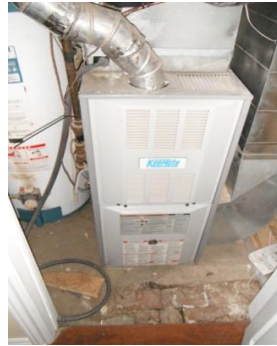
FORCED AIR FURNACE: [service annually](#)

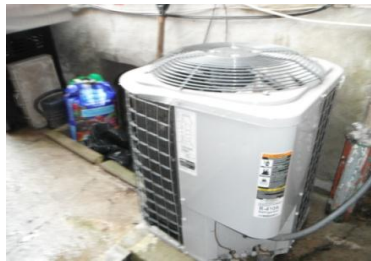
AIR CONDITIONER: not tested: should be serviced before using

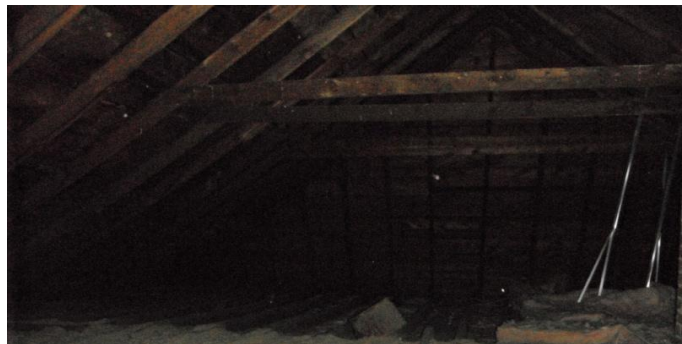
ROOF SPACE: viewed from neighbors access hatch, should consider installing access hatch
mostly no insulation, recommend installing for comfort and efficiency
